A piscatorial epistle

That sinking feeling

N T Brewster, C R Howie

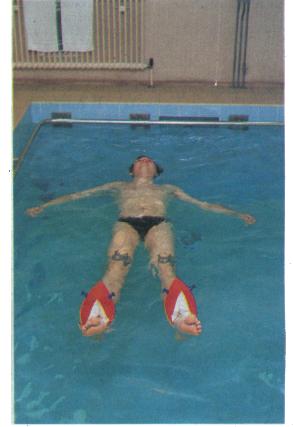
arm bands around the ankles easily corrected for this sinking tendency (figure).

Compensating for the added weight of replacement knee joints

Neoprene knee or ankle supports, which have intrinsic buoyancy, would be more practical. A medium neoprene knee brace will support half the weight of a medium knee prosthesis; with two neoprene knee braces buoyancy should be returned to normal. A greater moment of buoyancy is achieved if a
